historic structure report

CAPE COD FRENCH CABLE HUT

HISTORIC STRUCTURE REPORT
FRENCH CABLE HUT
CAPE COD NATIONAL SEASHORE
MASSACHUSETTS

January 1986

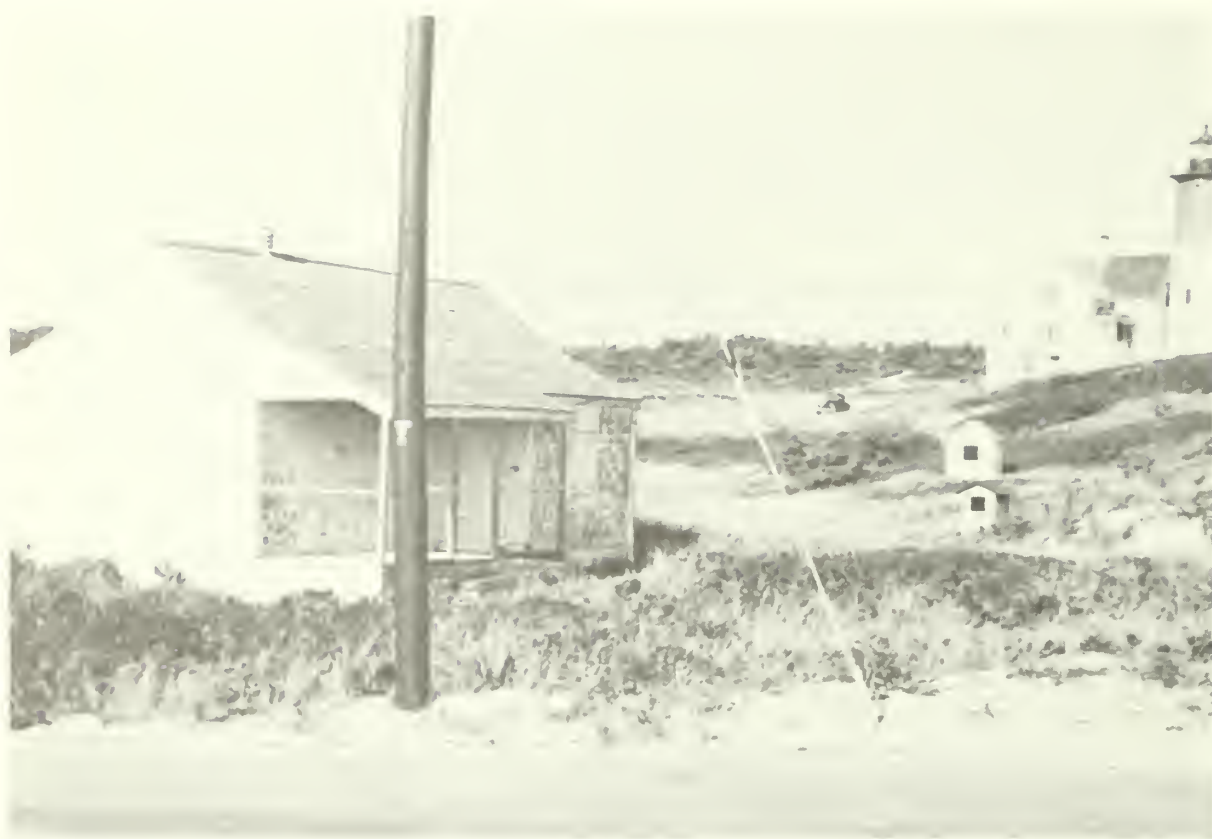
Figure 3
French Cable Hut Ca. 1950
Courtesy of the French Cable Station Museum
Orleans, Massachusetts

This view of the cable hut was made soon after Dorothy LePage enlarged it for a summer tourist cabin. The original hut comprised the porch and the room immediately behind it. LePage added two bedrooms at the rear and a kitchen on the far side. She changed the front entrance and window arrangement. The structure was resingled at the time it was remodeled. The terra cotta ventilator on the ridge of the roof was original and remains today.

added on the far side. The original front porch was not disturbed (Figures 2 and 3).

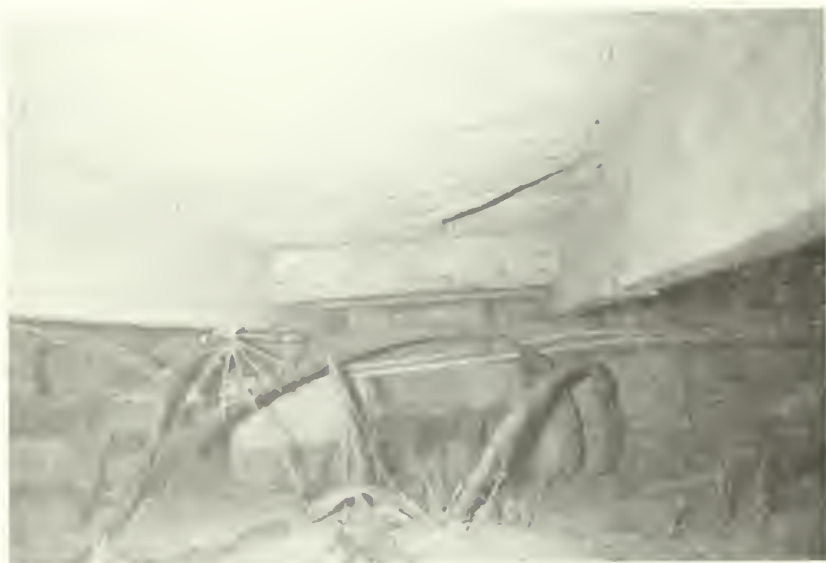
Figure 7

View of crawl space under living room, looking east
The end of the transatlantic cable

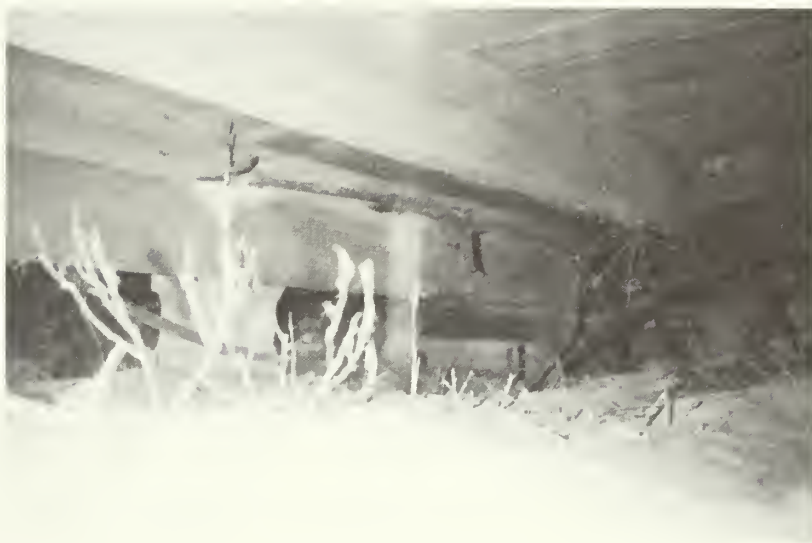
Figure 8

Same area as Figure 7, looking northeast

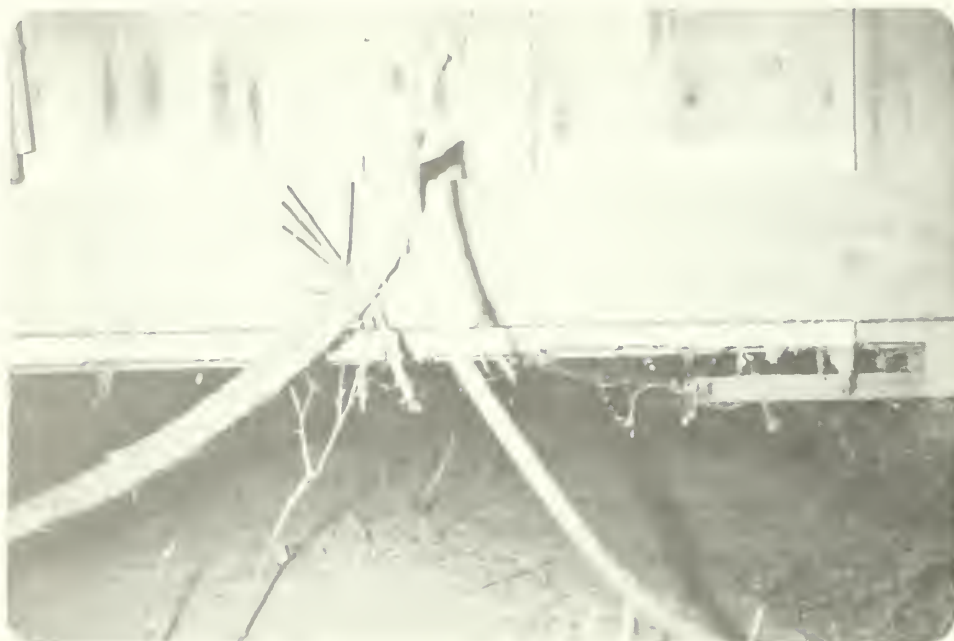
Figure 9

Crawl space under kitchen, looking south at the
former exterior shingles on north wall of
hut (covered by modern ledgers)

The form of the one story wood frame structure is clearly delineated on the drawings included in this report (Figures 4 and 5, Drawing No. 609/25,000). The shingle siding is unpainted. The historic shingles found in place in the basement are single coursed with exposure of 5" to 5 and 1/2" and widths of 3" to 5". These shingles were 10½" to 11" long. That may have been the full length of all shingles for two layer coverage on a wall surface or it may only have been a starter course for 16" to 18" shingles (Figure 9). Corner boards are one by sixes, butted.
